FIELD EVALUATION OF NDT DEVICES FOR DELAMINATION DETECTION OF HMA AIRPORT PAVEMENTS

Manuel Celaya, Ph.D. and Soheil Nazarian, Ph.D., PE

The University of Texas at El Paso (UTEP)

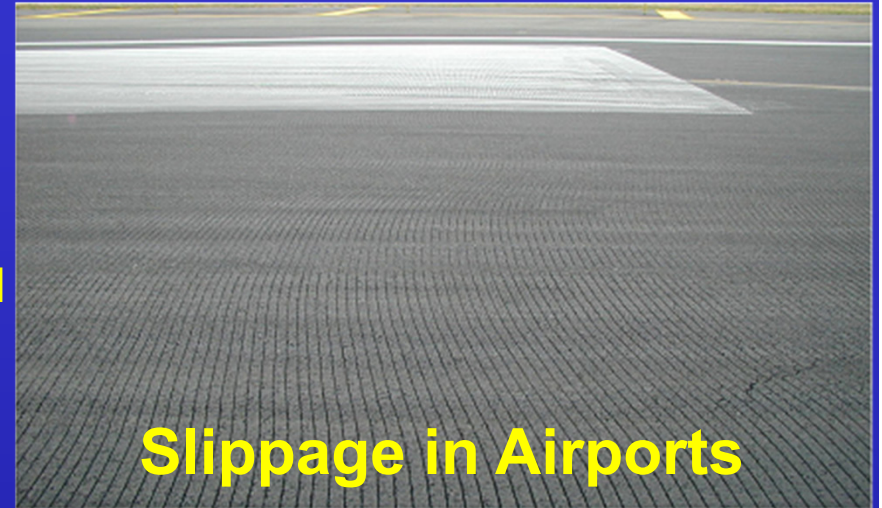
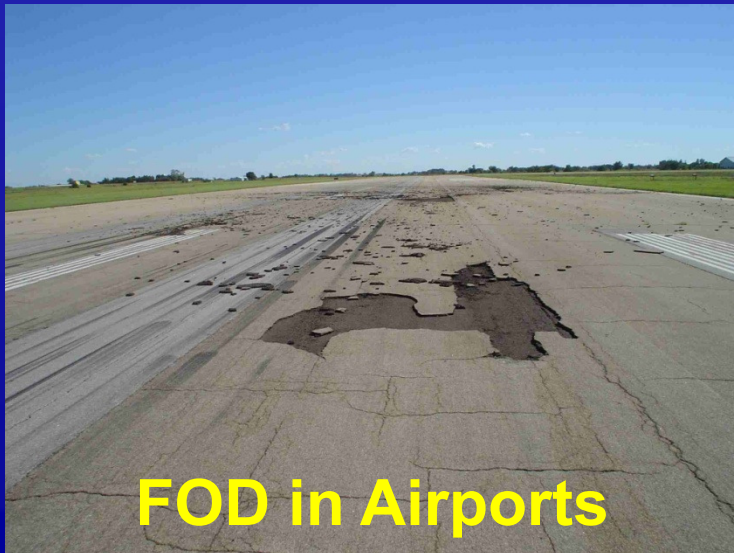
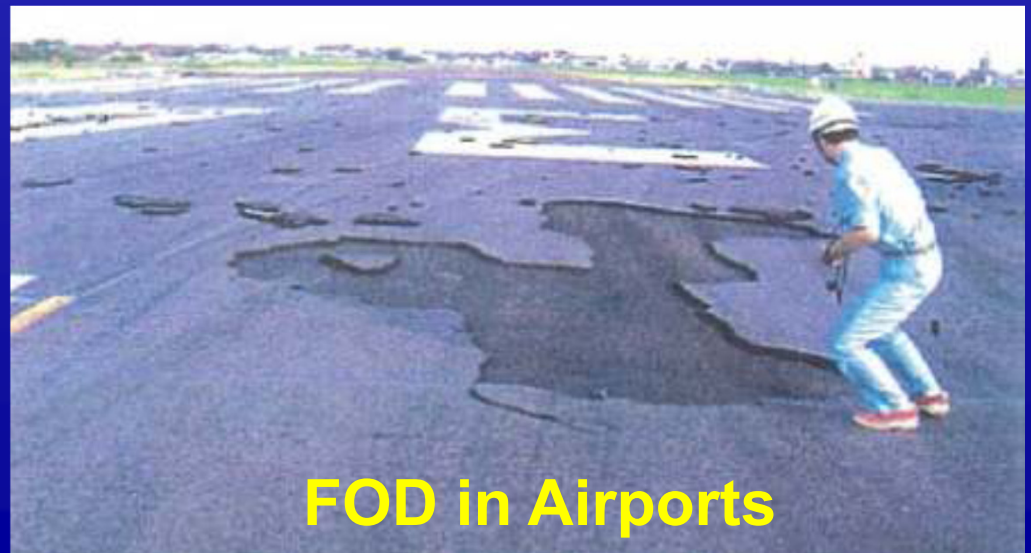
Delamination is more severe on airfield pavements, due to higher traffic loads (aircrafts).

Situation is critical where airplanes brake and turn, or on areas under large horizontal load (slippage).

May develop into foreign object debris (FOD), leading to runway closures.

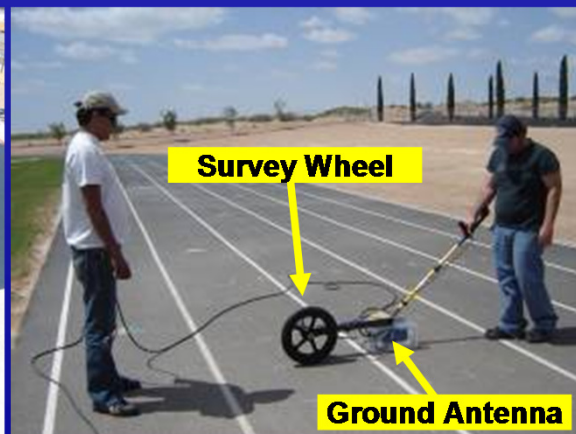
Ground-coupled (GPR)

Base on the transmission of electromagnetic waves.

Reflections of these waves at interfaces used to determine their location or depth, and to determine the properties of material.

GPR may be most suitable when the debonding is in severe stages or when moisture is present along the interface.

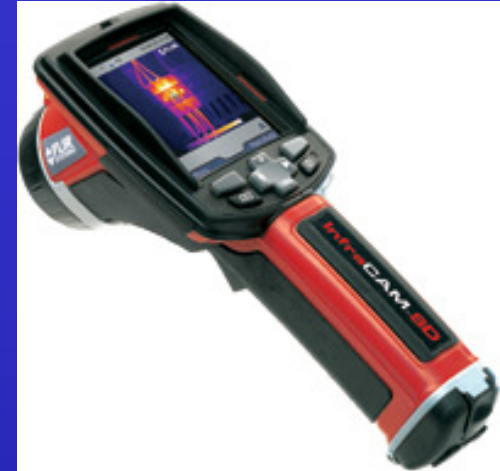
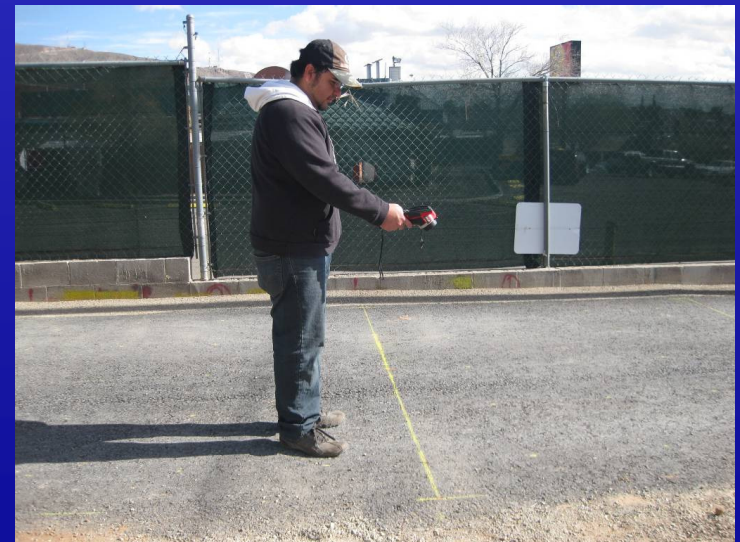
Infrared Image

Infrared Thermography measures temperature distributions across the surface of the pavement.

Used to detect the presence of shallow subsurface flaws in HMA.

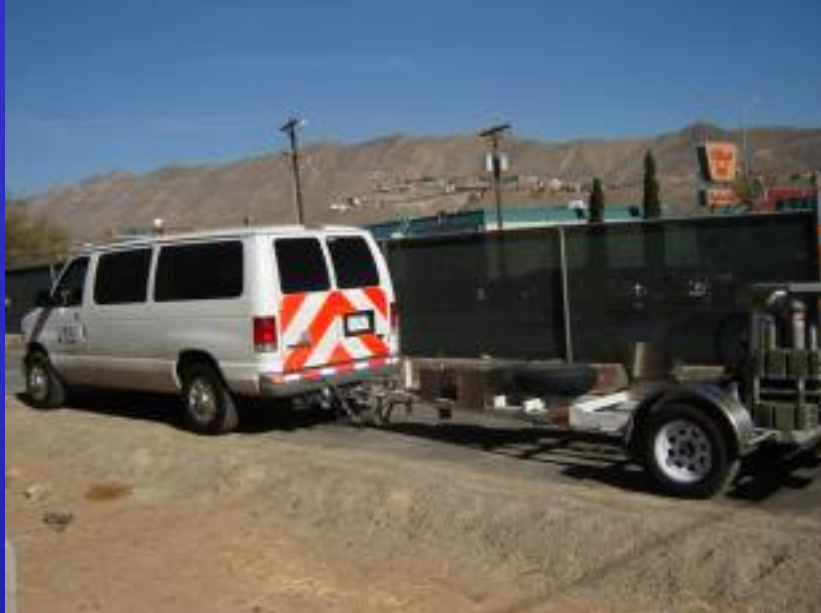
Impact loading mechanism and a set of seven geophones to measure vertical surface displacements. The entire system is trailer mounted.

The loading device is a 12 in. diameter load plate. An equivalent loads of 6,000 lbs was used.

First Geophone under the load plate. Other geophones at 1 ft interval.

Deflections of the first geophone and backcalculated modulus were used in this study.

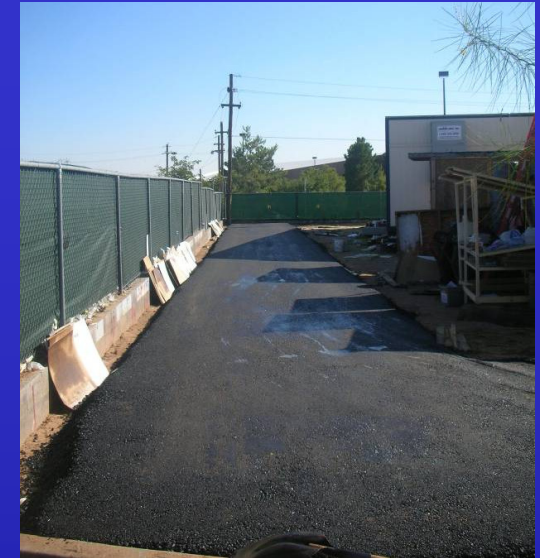
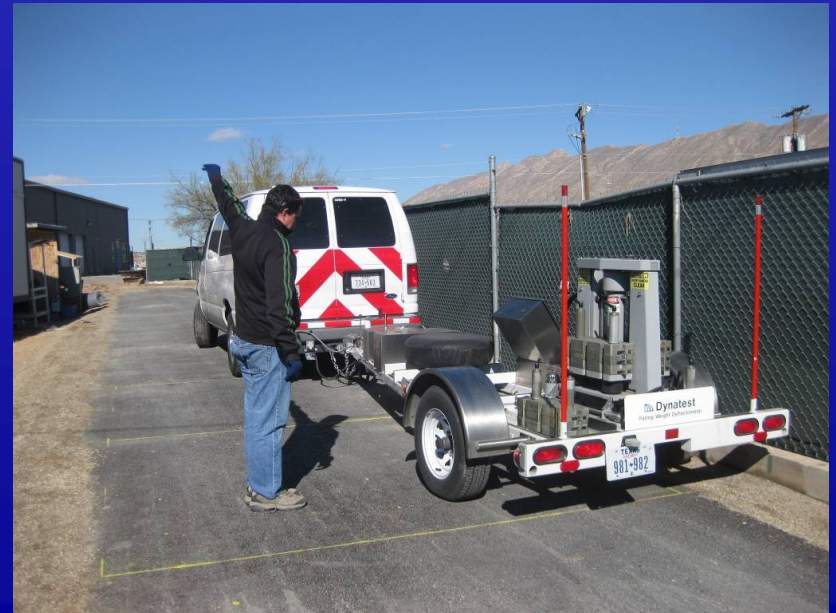
11 Different Sections constructed.

Two mixes: Fine (P-401) and Coarse (P-403)

Three levels of bonding between HMA: bonded, partially-bonded and debonded.

In addition, severe debonding was reproduced.

Two depths of debonding: shallow (2.5 in.) and deep (5 in.).

Different extents of delamination.

Reductions in modulus can be observed in most sections below depths of prepared debonding.

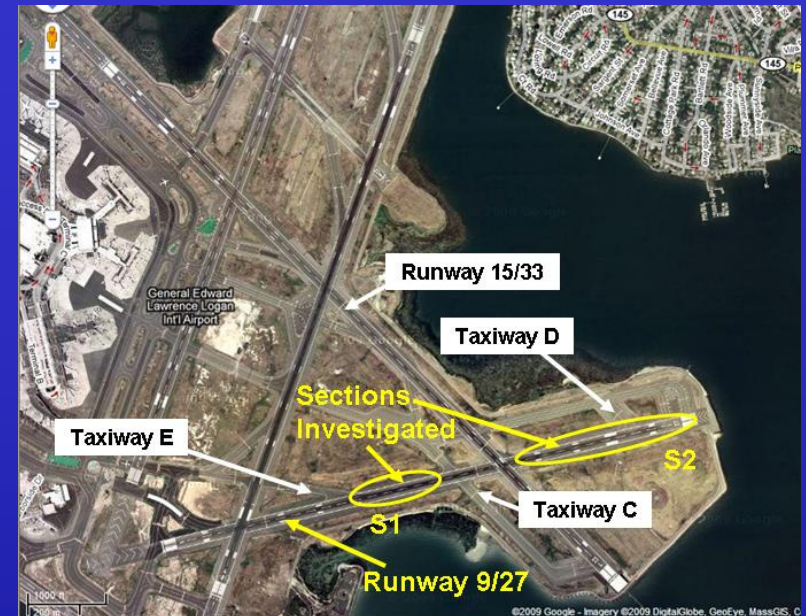
Boston Logan International Airport (BOS)

2 Sections Investigated

PSPA, GPR, and impulse Response

Validation coring

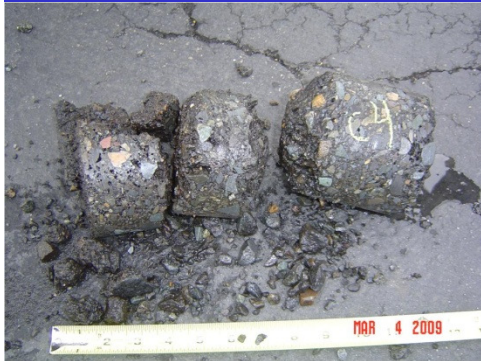
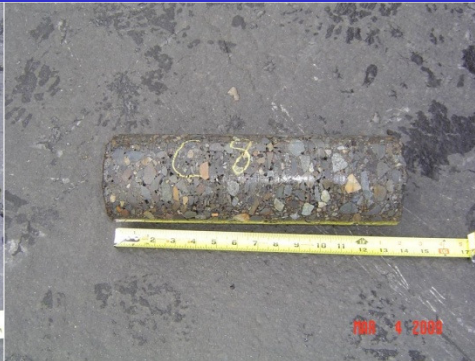
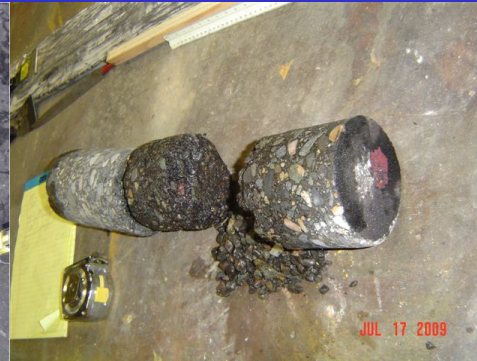
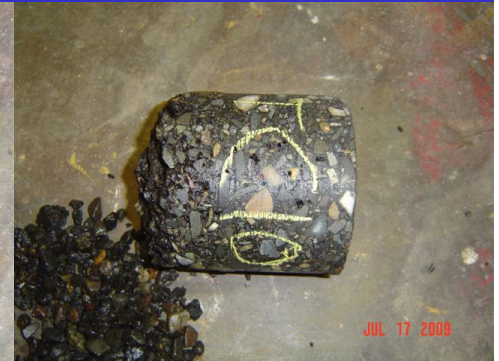
Section A5

PDX Coring Results

Core #	Location	GPR	PSPA	IR	FWD	Condition/Comments
B11	Line 2 @0 ft	Intact	Intact	Intact	Intact	Intact
B12	Line 1 @250 ft	Suspect	Intact	Intact	Intact	Intact
C7	Line 3 @0 ft	Suspect	Damaged	Damaged	Damaged	Low quality HMA, Core broken at 9.5 in.
C8	Line 3 @500 ft	Intact	Damaged	Damaged	Damaged	Low quality HMA, Intact
C10	L1 @160 ft from start	Intact	Damaged	Damaged	Intact	Stripping between top and middle layer
C3	L1 @100 ft from start	Intact	Intact	Marginal	Intact	Intact.
C4	L1 @140 ft from start	Intact	Intact	Damaged	Damaged	Some stripping at 9 in.
C5	L1 @160 ft from start	Intact	Intact	Damaged	Damaged	Intact
C6	L3 @280 ft from start	Damaged	Damaged	Damaged	Damaged	Severe stripping between each lift
Core 1	L2 @ 150 ft from start	Intact	Damaged	Marginal	Intact	Intact
Core 2	L3 @ 375 ft from start	Damaged	Damaged	Damaged	Damaged	Intact/Low quality HMA
Core A	L1 @0 ft from start	Damaged	Damaged	Damaged	Damaged	Intact/Low quality HMA

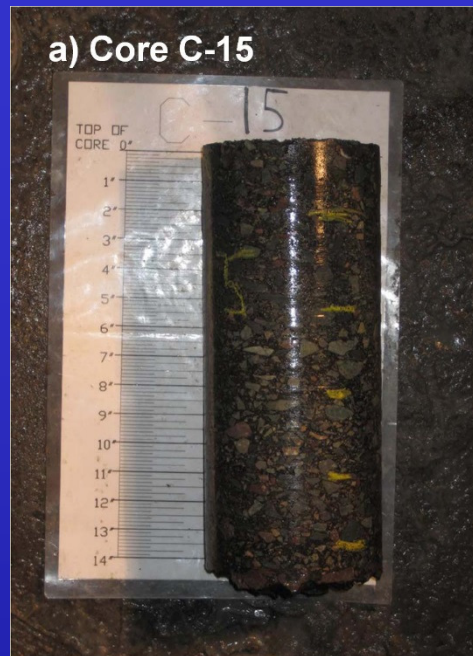
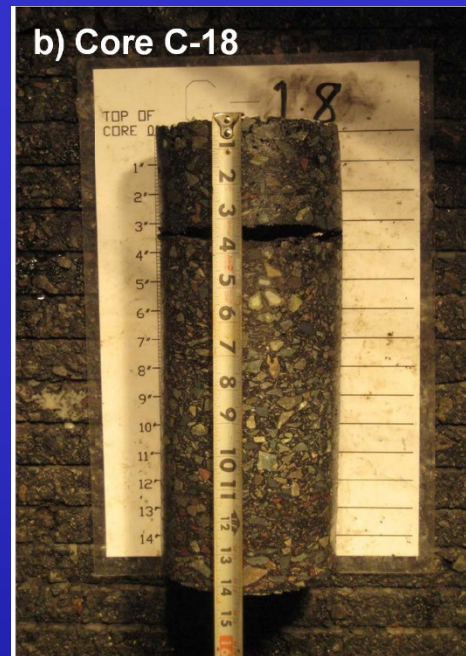
Section 1

BOS Coring Results

Core #	Location	GPR	PSPA	IR	Condition/Comments
C-15	929+50 @40'R	Intact	Intact	Intact	Intact
C-16	931+00 @60'R	Damaged	N/A	N/A	Intact
C-17	932+50 @10'L	Damaged	Marginal	Intact	Debonding at 6 in.
C-18	934+00 @10'R	Damaged	Damaged	Damaged	Debonding at 3 in.
C-19	935+50 @40'R	Damaged	N/A	N/A	Debonding at 7 in.
C-28	949+00 @40'L	N/A	Marginal	Intact	Intact
C-29	950+50 @10'L	N/A	Intact	Damaged	Intact
C-30	952+00 @10'R	N/A	Damaged	Damaged	Debonding at 6 in.
C-30A	952+05 @10'R	N/A	Marginal	Intact	Intact
C-31	953+50 @40'R	N/A	Intact	Intact	Intact
C-32A	954+95 @65'R	N/A	Intact	Intact	Intact
C-33	956+50 @60'L	N/A	Intact	Intact	Intact
C-34	958+00 @40'L	N/A	Intact	Intact	Intact
C-35A	959+50 @10'L	N/A	Damaged	Intact	Debonding at 7 in.
C-36	961+00 @10'R	N/A	Intact	Intact	Intact
C-37	962+50 @40'R	N/A	Intact	Intact	Core rig malfunctioned at core had to be stopped at 9 ½".
C-38	964+00 @60'R	N/A	Intact	Marginal	Intact
C-39	965+50 @60'L	N/A	Marginal	Marginal	Debonding at 4 in.
